From: Rob Wilson
 To: "Kirsten Dell-Hartgers"; Garry Van der Krogt
 Cc: Margaret Waller; Les Wilson
 Subject: RE: Cashmere High - id 340 - monthly fire alarm and sprinklr testing
 Date: Monday, 11 February 2019 6:21:37 p.m.
 Attachments: [REDACTED]

Subject: Fire Systems failures

Project: Cashmere High School – Argest Major Defect Remediation

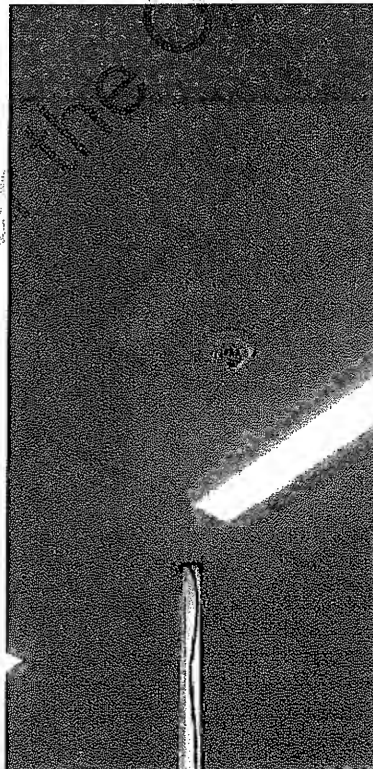
Cover removed by Cashmere High School Caretaker – Confirmed by Optimus Fire

Photo show smoke with no cover

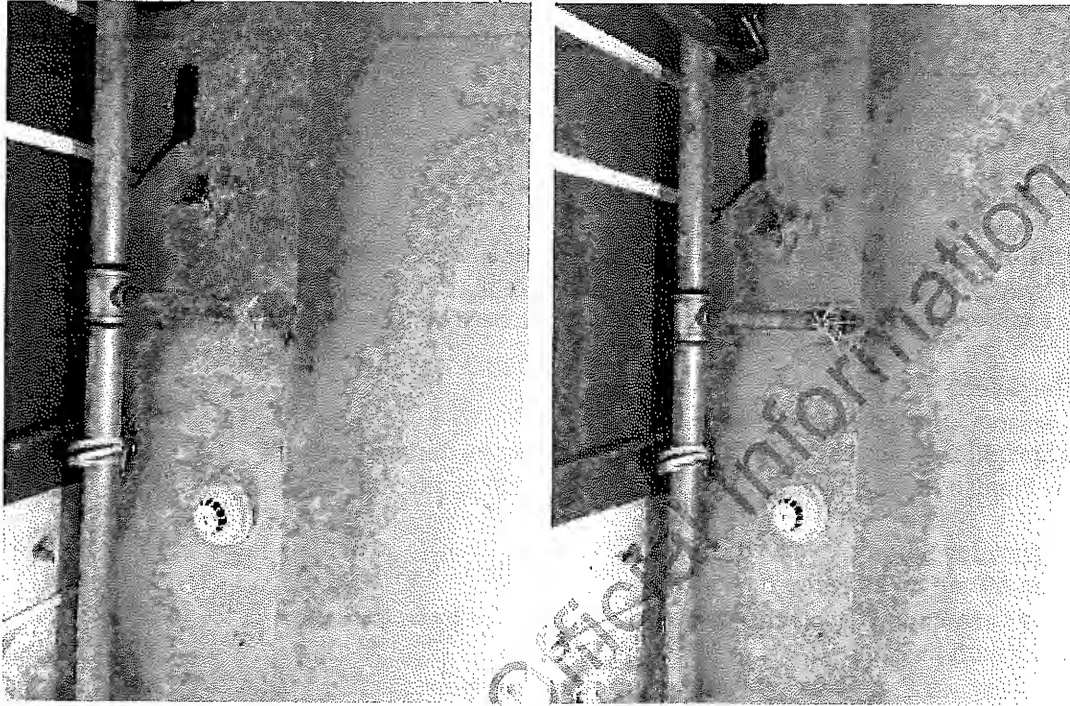
2. Gym smoke detector and sprinkler head covered by store room exit

We understand this was sorted by Cashmere High School Caretaker however we found a Gym store room with plastic cover over sprinkler head held with blue tape. We removed the plastic cover.

Photo 1 shows plastic on, Photo 2 shows plastic removed

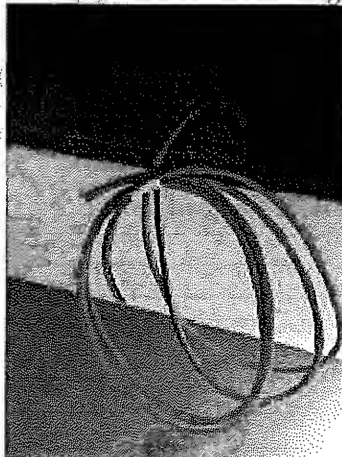
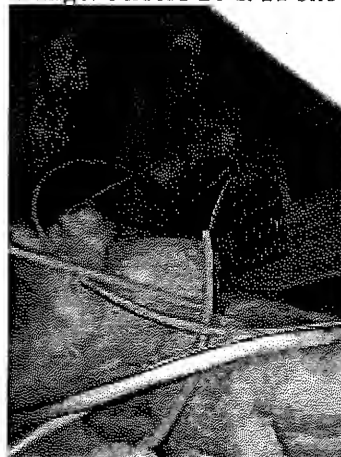
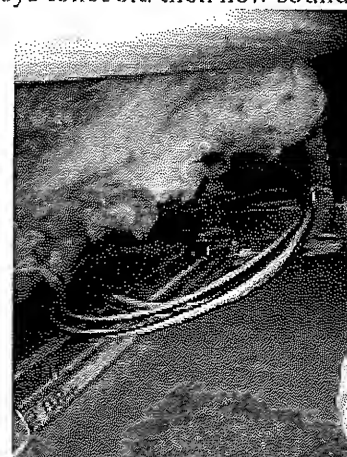
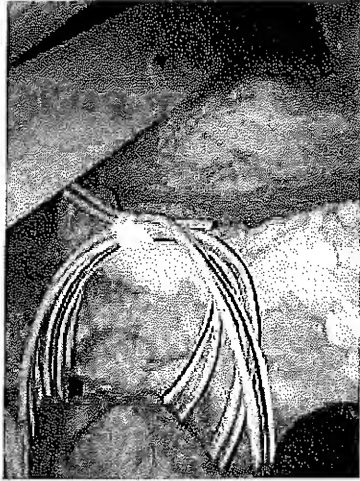
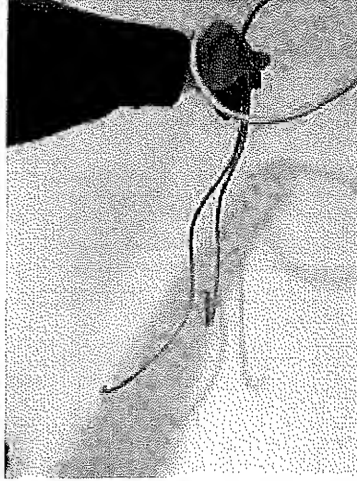
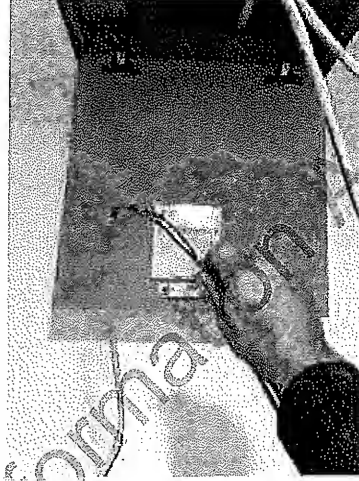
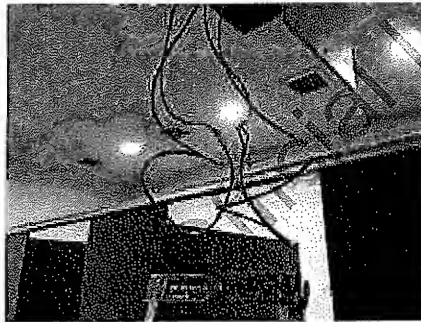
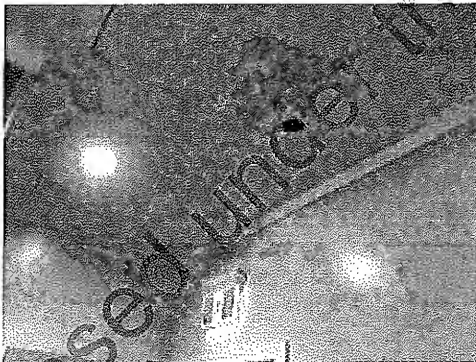
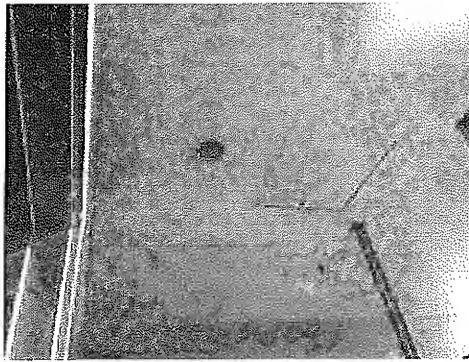
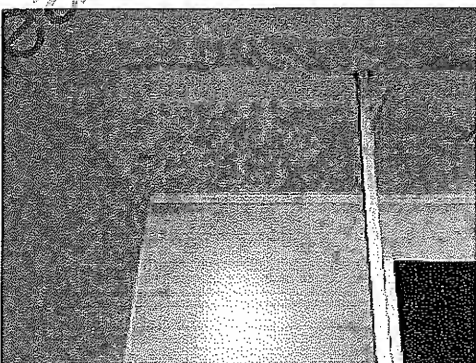
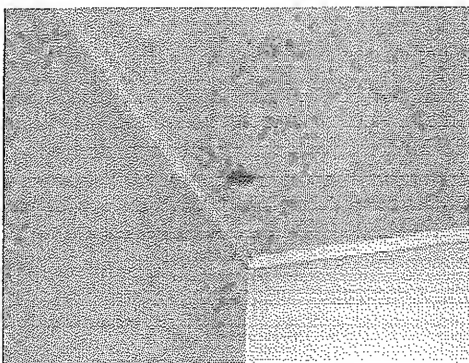
3. Gym toilet/changing rooms low sound levels

We investigated the evacuation devices in the Gym toilet/change areas and found several devices not working. Speakers which failed had no monitoring voltage which they should have if they were in circuit. We accessed the roof void and found five (5) open circuits on the evacuation feed. We expect these were wired for during installation but never brought through the gib. All five open circuits were junctioned which allowed some failed sounder to operate however two (2) still failed. Replaced these old Ampac sounders with new Pertronic ones which operated correctly. The old Ampac sounders were found to be problematic in the past including the grills falling off and were no longer sold as a result.

Photo 1 to 5 shows all 5 open circuits. Photo 6 & 7 show crimp joins to repair circuit. Photos 8 & 9 show old and new sounder in girls change. Photos 10 & 11 show boys toilet old then new sounders.

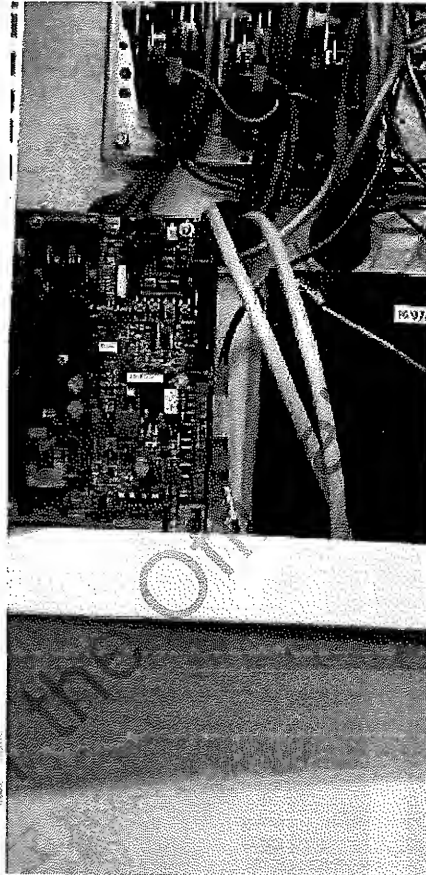
We carried out an impedance test on the evacuation feed to Amplifier 3 and found it to be just over 90Watts. The Amplifier is rated at a maximum of 50Watts so is well overrated. We purchased an FP1116 – 120Watt T-Gen which as stated is rated at 120Watt, 30Watts over the current evacuation load. This was installed, made into the master amplifier and tested ok.

Photo 1 shows the new 120Watt Amplifier installed in the MX1 panel. The green normal light is top centre and the green LCD display is showing normal screen.

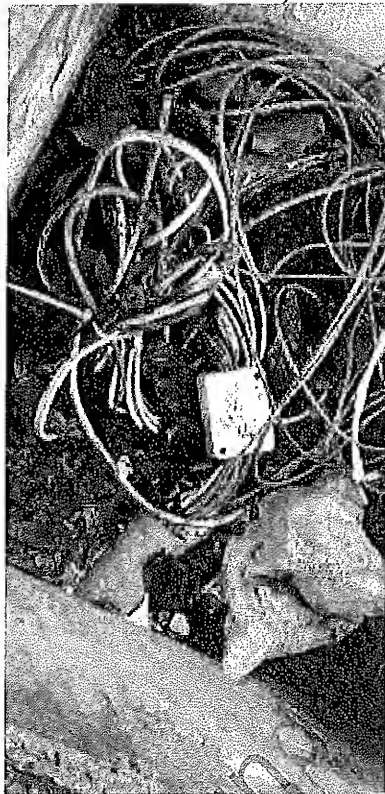
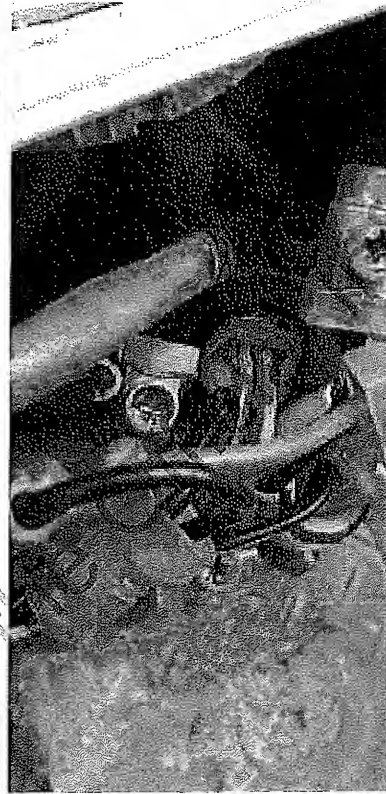
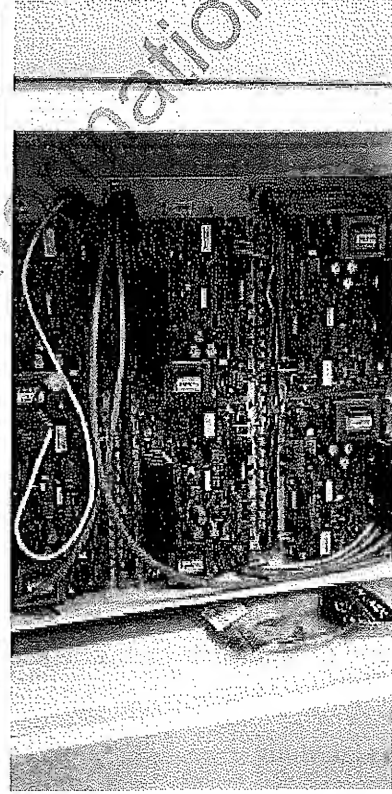
5. Sounder fault on Amp 4 needs attention as this is causing a fault on the panel. We carried out fault finding on evacuation circuit for Amplifier 4. The fault tended to come and go. We tracked it back to some underground junctions that were inadequately terminated. These junctions were temporarily made good and the fault cleared. No sign of a fault on this Amplifier has since occurred. The temporary junction will not cause issue but will require a permanent water protected join which we will look at doing week starting 15 July 2019 during School Holidays. Photo 1 shows underground junction with inadequate water protected terminations. Photo 2 shows another major junction on the side of the Administration Block which also required improved terminations. Photo 3 shows ALL Amplifiers in normal state (defect state shows a bright yellow LED on the left of the board).

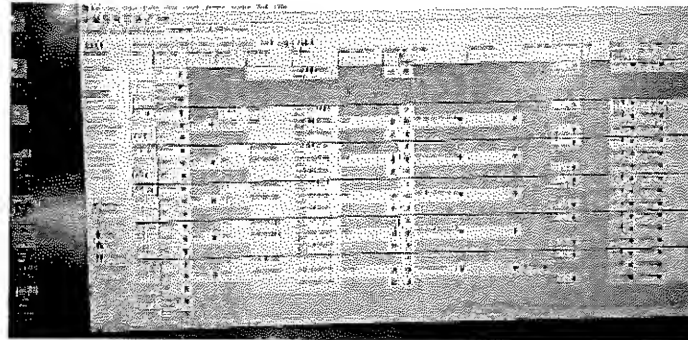
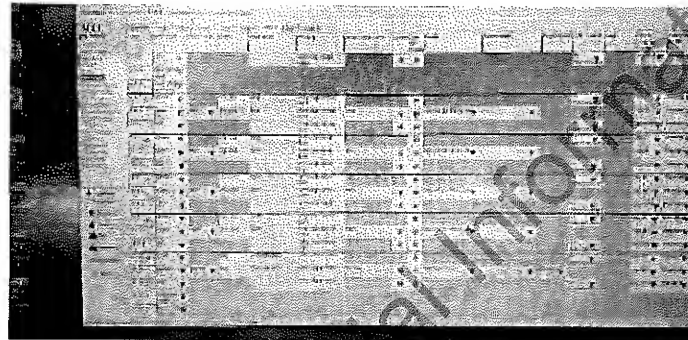
6. 5 minute delay on sounder operation and brigade calling on smoke detectors, sounders are to be instant the delay on the brigade calling is to remain. The 5 minute delay has been changed in the config as required. The fire system now has immediate evacuation on activation of a smoke detector, MCP or sprinkler. There is a 5 minute delay on the Fire Service calling on smoke detectors but not on MCP's or Sprinkler. Photo 1 shows a snapshot of part of the config with smoke evac delay. Photo 2 shows the same section without smoke evac delay.
